Contract #: 04-0120F4Cty: SF/ALA Rte: 80 PM: 13.2/13.9File #: 69.28**WELDING INSPECTION REPORT****Resident Engineer:**Siegenthaler, Peter**Address:** 333 Burma Road**City:** Oakland, CA 94607**Report No:** WIR-018561**Date Inspected:** 02-Dec-2010**Project Name:** SAS Superstructure**OSM Arrival Time:** 700**Prime Contractor:** American Bridge/Fluor Enterprises, a JV**OSM Departure Time:** 1900**Contractor:** Zhenhua Port Machinery Company, Ltd (ZPMC), Changxing Island **Location:** Shanghai, China

WELDING INSPECTION REPORT

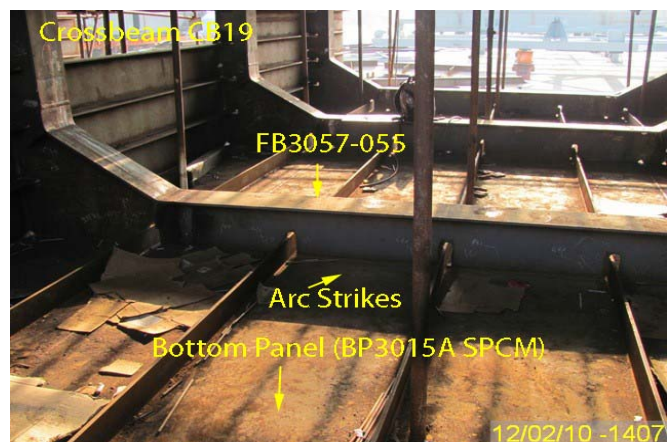
During random in process inspection of Orthotropic Box Girder (OBG) member identified as Crossbeam CB17, this QA observed arc strikes on Piece Mark (PCMK) identified as BP3015A. This QA marked the affected areas and informed ZPMC Quality Control (QC) identified as Mr. Feng ya jun of this issue. Mr. Feng ya jun informed

this QA that the arc strikes would be corrected in a manner compliant with the contract documents. See attached pictures.
